Docket No. 217 – Development and Management Plan Inspection

Northeast Utilities Service Company Certificate of Environmental Compatibility and Public Need for the construction of a 345-kV electric transmission line and reconstruction of an existing 115-kV electric transmission line between Connecticut Light and Power Company's Plumtree Substation in Bethel, through the towns of Redding, Weston, and Wilton, and to the Norwalk Substation in Norwalk, Connecticut.

Date: October 4, 2006

Inspector: Lee Curtis, Susan Infalt, BSC Group

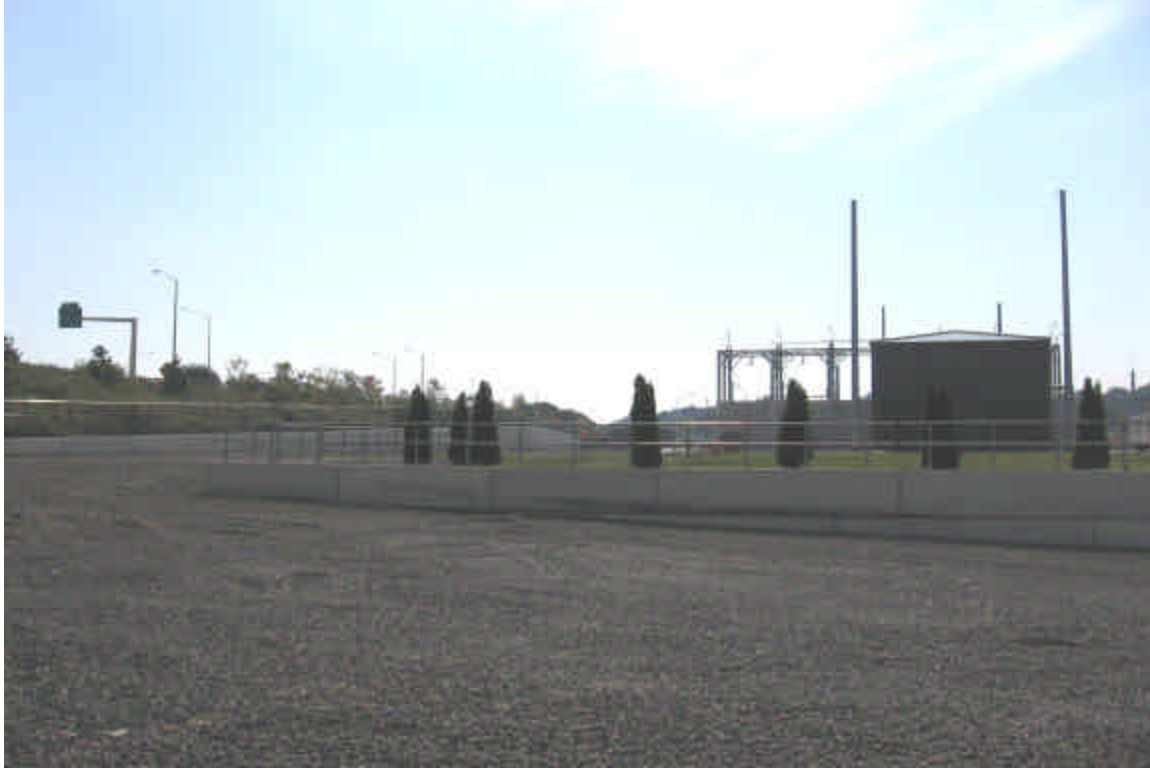
(Norwalk Substation): Photo shows a view of the substation yard. The grassed area near the GIS building is in good shape. 10/04/06

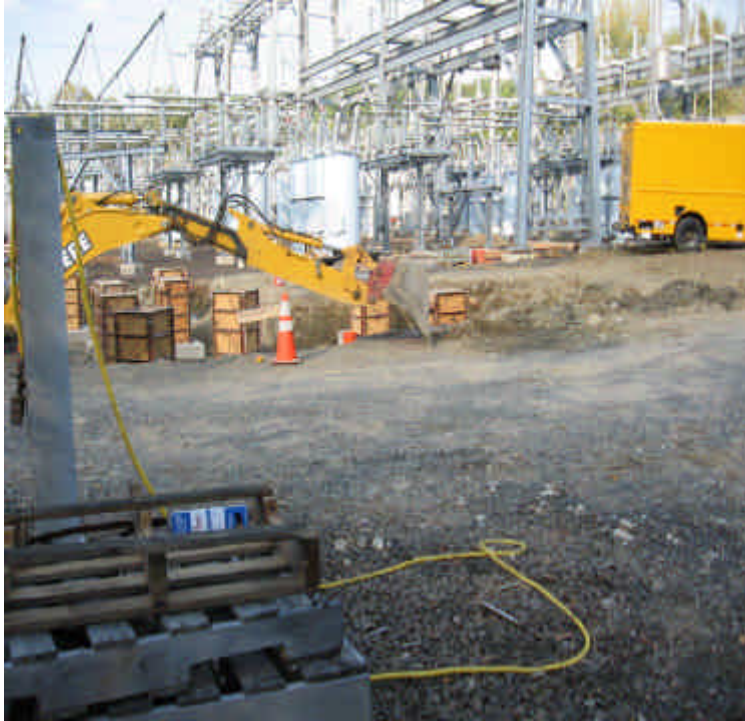
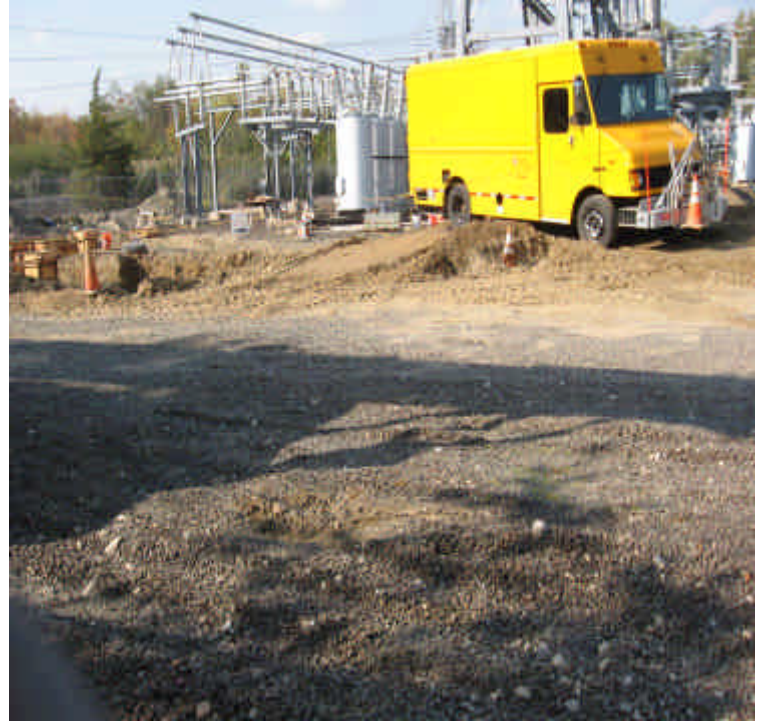
(Plumtree Substation): Both photos show active work, related to the Plumtree to Triangle ROW project, occurring at the southwestern corner of the substation. Both views show the excavation work and equipment storage. All sediment is currently contained on site but controls are needed. This is not jurisdictional under the Bethel to Norwalk project. 10/04/06.
